Good Engineering, Hot Glue, Combine To Save Time And Add Rig Life

Willingness to "think outside the box" pays off in a safe, efficient dry tow that has increased the life expectancy of the Glomar Labrador I jackup by a factor of at least 10.

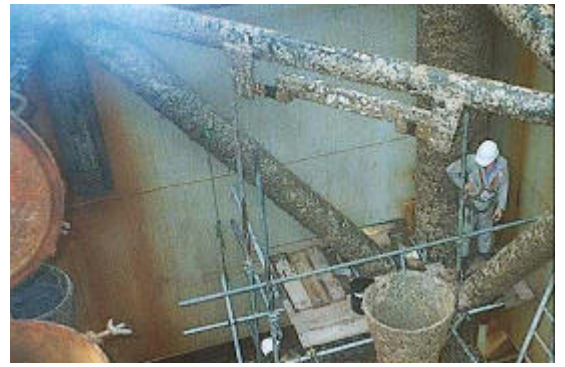
the vice president of operations, the rig manager and technical staff from Aberdeen. Several consultants prepared detailed analytical studies including structural modelling of the combined heavy lift vessel with the *Labrador I* secured on board. The shipping company prepared studies defining the cribbing, docking points and sea fastening, as well as the best arrangement of the *Labrador I* on board the heavy lift ship, *Mighty Servant II*.

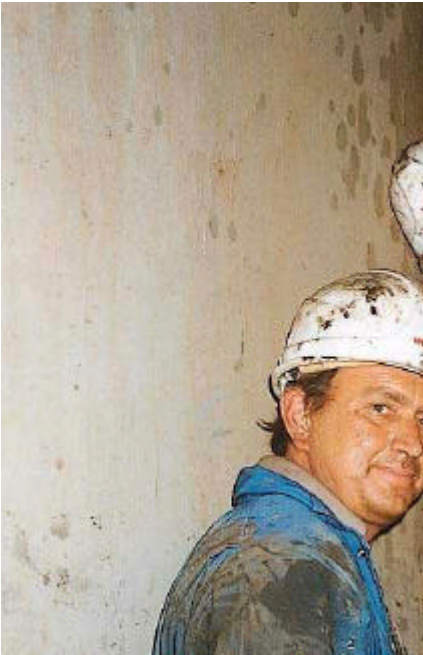
The *Labrador's* legs are held in place horizontally by semi-cylindrical „push-only" type guides which have a lateral clearance of up to 1.5 in. allowing for some movement of the legs during tow. The jacking mechanism allows for up to 3.25 in. of vertical movement. The most critical aspect of towing operations was to restrain

the movement of the legs in the guides both horizontally and vertically to prevent destructive vibration. This restraint is usually accomplished by half-moon-shaped steel chock plates. Recent experience demonstrated that these steel chocks, while quite acceptable for local tows or short duration field moves, were not of sufficient strength or durability to endure the rigors of an extended, open-sea dry tow of about 30-35 days.

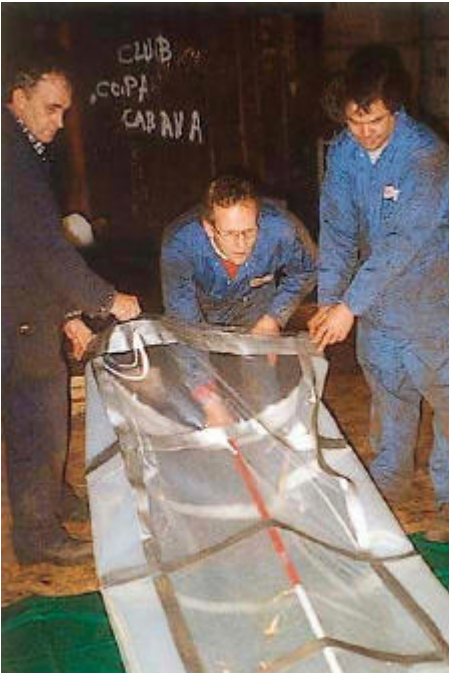
minute bubbles entrained during mixing. The top of the bag was allowed to bulge over the top of the guide, and a band of fine steel mesh was inserted to form a cap facilitating chock removal at the end of the tow.

The **WEICON** material hardened in 3-4 hours and the internal heat it generated during curing created a solid chock too hot to touch. The material had extremely high compressive strength (20.6 ksi), and was initially thought to be flexible enough to absorb the slow cyclic loadings imparted to it during the tow. **WEIDLING C** is not resistant to shock loads, such as a blow from a hammer, making it easy to break out when it is time to remove the chocks. The bags, coated with the release agent, allowed the barge master to jack up two to three teeth, pushing the whole chock up and out of the guide slot. Then, workers easily broke off the cap just below the steel mesh with sledgehammers. After jacking back down five to six teeth, the chock stayed up above the guide. Two or three repetitions of this jacking sequence taking 2 to 4 hours per leg, were required for the guide to be free and clear for operations as usual.

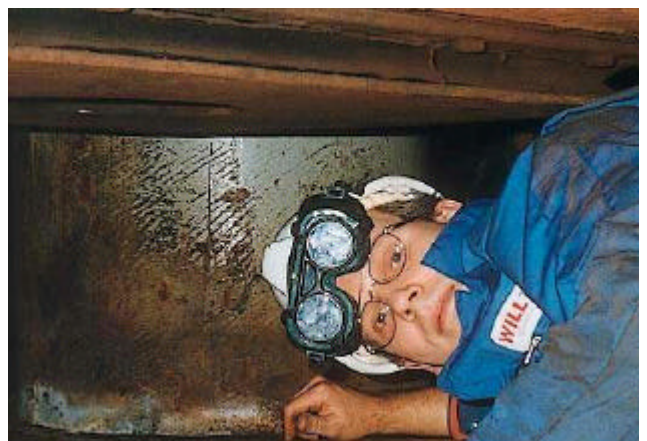
In fact, the revised pouring method only appeared to solve the problem. Although hard to the touch, the **WEIDLING C** requires at least 24 hours to cure, completely aligning the long-chain polymers. Apparently, the tow departed before curing of the center of the chocks was complete. On the 15th day of the Atlantic crossing, the constant flexural stresses imposed by the legs on the guides started to damage the upper chocks' edges reducing their coverage from 96% to about 80%. It appeared that the guides imparted some shear and bending loads to the chocks, cracking them and

eventually allowing them to shift.

The ability to make field repairs onsite without special equipment proved to be advantageous. Anticipating a stop in Rio de Janeiro, Brazil, the team analysed the problem and redesigned the chocks to include embedding a Kevlar rope around the perimeter to reinforce the edges and eliminate chock shifting. In addition, the formulation of the **WEIDLING C** was altered to build in variable flexibility in the high stress areas. During the 5-day journey from Recife to Rio de Janeiro, temporary wooden chocks and aluminium shims were installed to support the legs in transit. Several coupons were poured and tested, then the damaged **WEIDLING C** chocks were removed and repoured using the new design when the ship arrived in Rio de Janeiro. This time, full curing protocol was observed before the tow continued southward.
